INDOOR AIR QUALITY ASSESSMENT

**Department of Children and Families
1530 River Street
Hyde Park, MA**

Prepared by:
Massachusetts Department of Public Health
Bureau of Environmental Health
Indoor Air Quality Program
August 2017

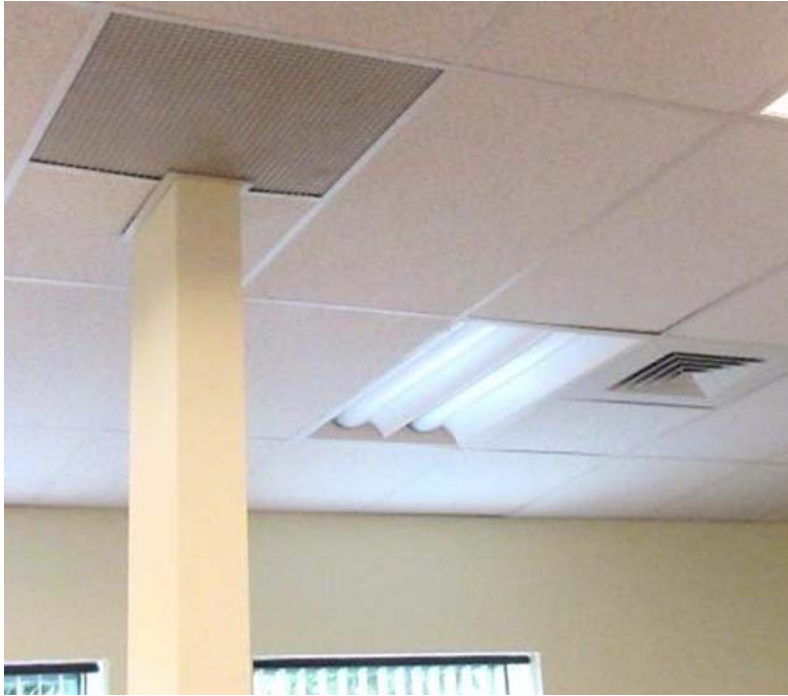
Picture 1

Fresh air is provided by air handling units (AHUs) located on the roof. Air from the AHUs is filtered, heated/cooled, and delivered to rooms via ducted supply vents (Picture 1). Air is returned/exhausted through exhaust grills (Picture 1). It is recommended that HVAC systems be re-balanced every five years to ensure adequate air systems function (SMACNA, 1994). It is not known when the last time these systems were balanced.

Typical supply (right rear) and exhaust vents

1. Operate supply and exhaust ventilation in all areas during occupied periods.
2. Have the HVAC system balanced every 5 years in accordance with SMACNA recommendations (SMACNA, 1994).

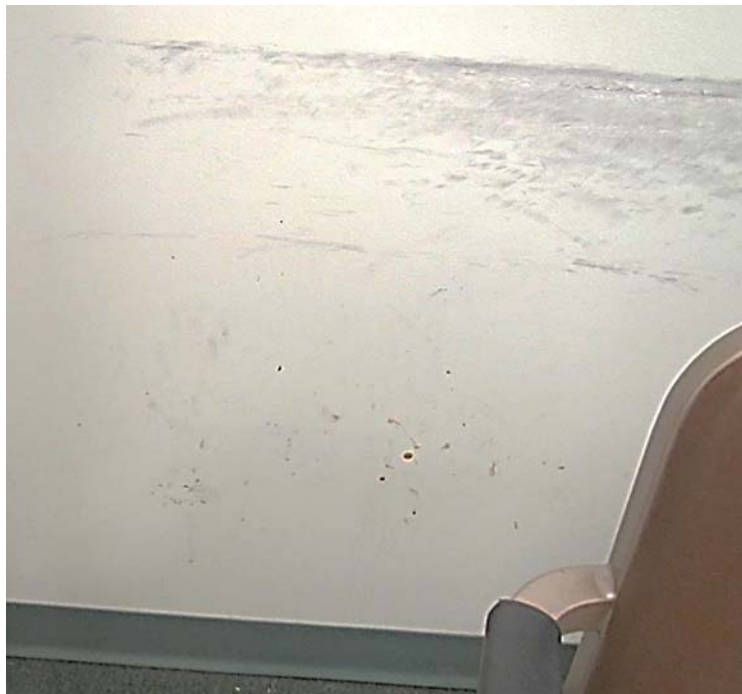
Picture 2

A water-damaged ceiling tile was observed in an office on the other side of the building, which was reported to be from a historic leak. Water damage to a wall in an office was observed (Picture 2) that appeared to be caused by a coffee pot. The wall was also soiled and should be cleaned. The computer room had a ductless air conditioner on the wall with a water stain (Picture 3) indicating that the condensate from this unit had leaked in the past. Condensate pumps and associated piping from these units should be checked periodically for clogs and leaks and no porous materials should be stored underneath. It was reported that due to security concerns, this area is only infrequently accessible to cleaning staff which makes it more difficult to detect problems.

Water-stained, soiled wall

4. Replace any water-damaged ceiling tiles when they are discovered and repair leaks as needed.
5. Clean water-damaged, soiled wall in Picture 2.
6. Ensure that the condensate removal system for the ductless air conditioning unit is functioning and is not clogged or leaking. Due to access issues with this room, consider regularly scheduled supervised access to this area for monitoring and cleaning. Ensure that no items are stored underneath the ductless unit.

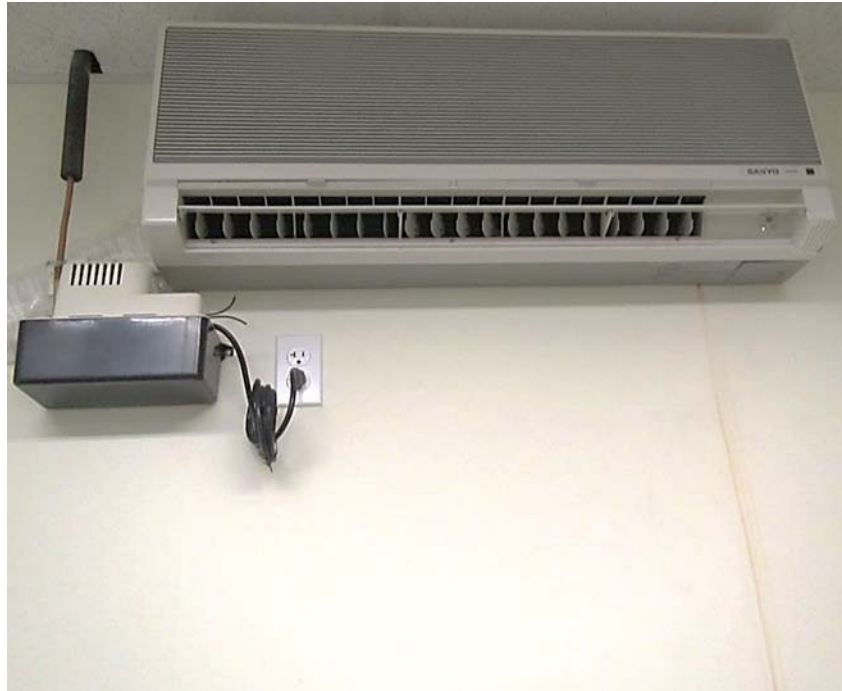
Picture 3

Ductless air conditioning unit with water stain on wall

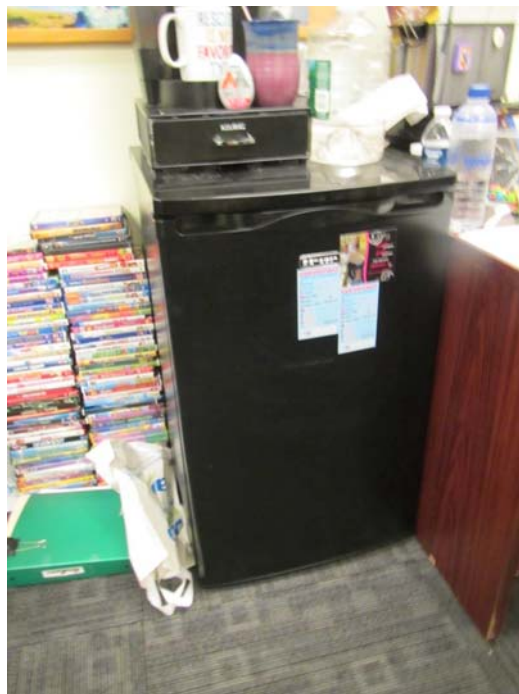
Picture 4

Refrigerators, including a large one in the hallway next to the kitchen, a refrigerated vending machine, and water dispensers were observed in carpeted areas (Pictures 4 and 5; Table 1). These appliances may spill or leak and lead to carpet damage and microbial growth. It is recommended that these appliances be located in areas without carpeting or on waterproof mats. Carpet squares could also be replaced with tile in areas where water dispensers and refrigerators are located. Refrigerators should be kept clean to prevent odors and microbial growth.

Small refrigerator on carpet, note coffee maker

7. Consider locating refrigerators and water dispensers in non-carpeted areas. Clean refrigerators out regularly to avoid odors and microbial growth.
8. Ensure that any humidifiers used in the office are properly maintained to prevent odors and microbial growth.

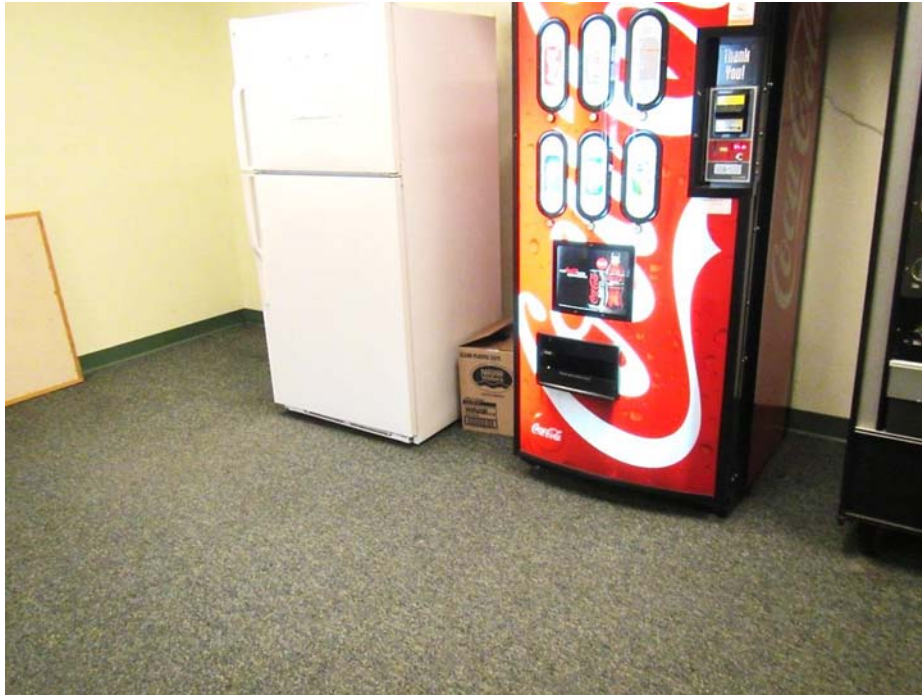
Picture 5

Refrigerator and refrigerated vending machine on carpet

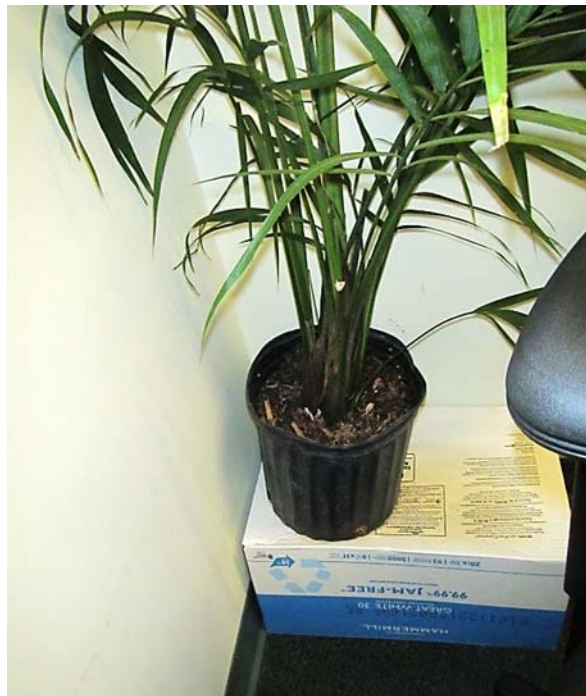
Picture 6

Plants were found in some offices. Some were without drip pans and/or placed on porous materials such as carpeting and boxes (Picture 6). Plants should be well maintained, not overwatered and placed on non-porous drip pans which are cleaned of debris regularly.

Plant on porous box

9. Ensure that all plants are properly maintained, not overwatered, and placed on waterproof drip pans instead of on porous items. Ensure water for cut flowers is changed regularly to prevent odors.

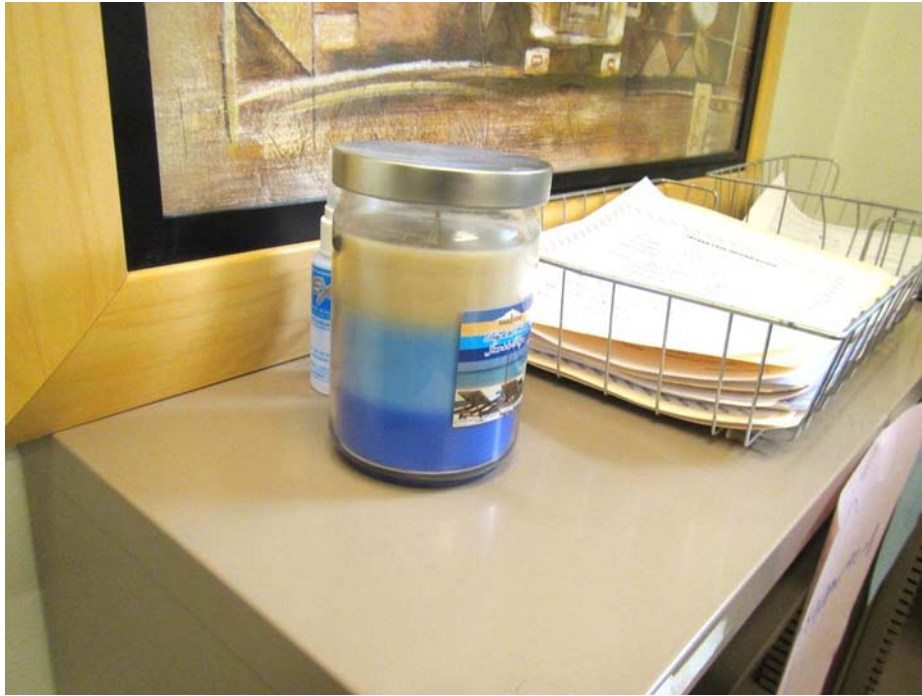
Picture 7

Exposure to low levels of total volatile organic compounds (TVOCs) may produce eye, nose, throat, and/or respiratory irritation in some sensitive individuals. To determine if VOCs were present, BEH/IAQ staff examined rooms for products containing VOCs. BEH/IAQ staff noted cleaners, hand sanitizers and various scented products such as candles in use within the building (Picture 7; Table 1). All of these products have the potential to be irritants to the eyes, nose, throat, and respiratory system of sensitive individuals.

Scented candle

10. Reduce use of products containing VOCs including eliminating air freshening and scented products.
11. Keep food in sealed pest-proof containers. Keep cooking equipment clean to prevent smoke, odors and the attracting of pests.

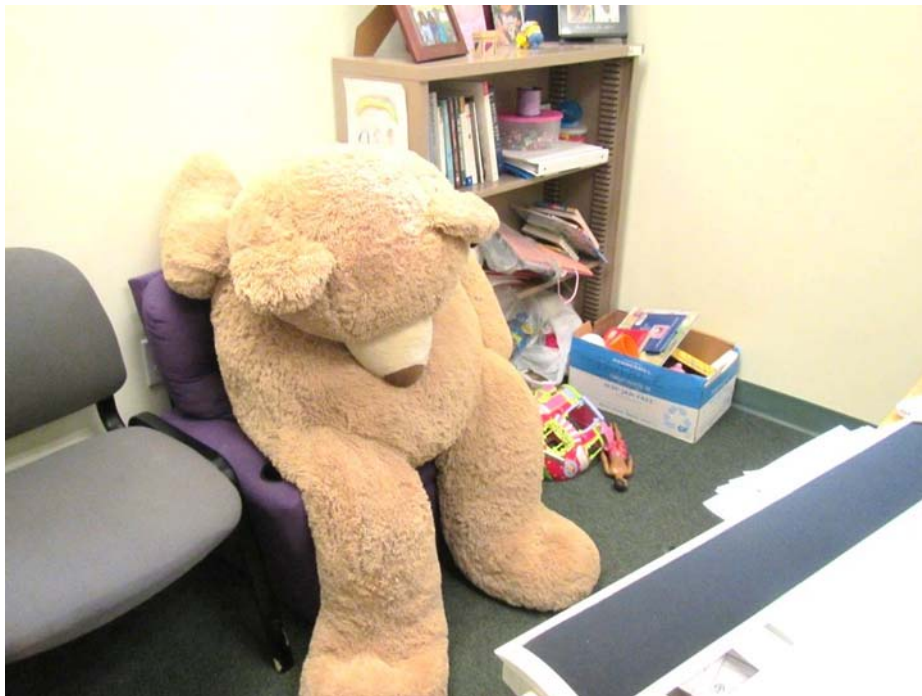
Picture 8

Upholstered furniture and plush toys were observed in offices (Picture 8). These should also be cleaned regularly to remove the build-up of oils and debris.

Plush toy and upholstered furniture, also note boxes on the floor

12. Clean carpeting in accordance with IICRC recommendations (IICRC, 2012). Continue with plans to replace carpeting that is beyond its service life.
13. Clean upholstered and plush items regularly to remove dust, oils and debris.
14. Reduce accumulated materials on flat surfaces and store in an organized manner to allow for thorough cleaning. Continue with plans for new/reorganized storage space for items such as clothing, toys and car seats. Ensure that storage methods keep items off the ground and protected from moisture and dusts.
15. Clean the blades of personal fans, supply, and exhaust vents periodically to avoid aerosolizing dusts.
16. Refer to resource manual and other related IAQ documents located on the MDPH's website for further building-wide evaluations and advice on maintaining public buildings. These documents are available at: <http://mass.gov/dph/iaq>.

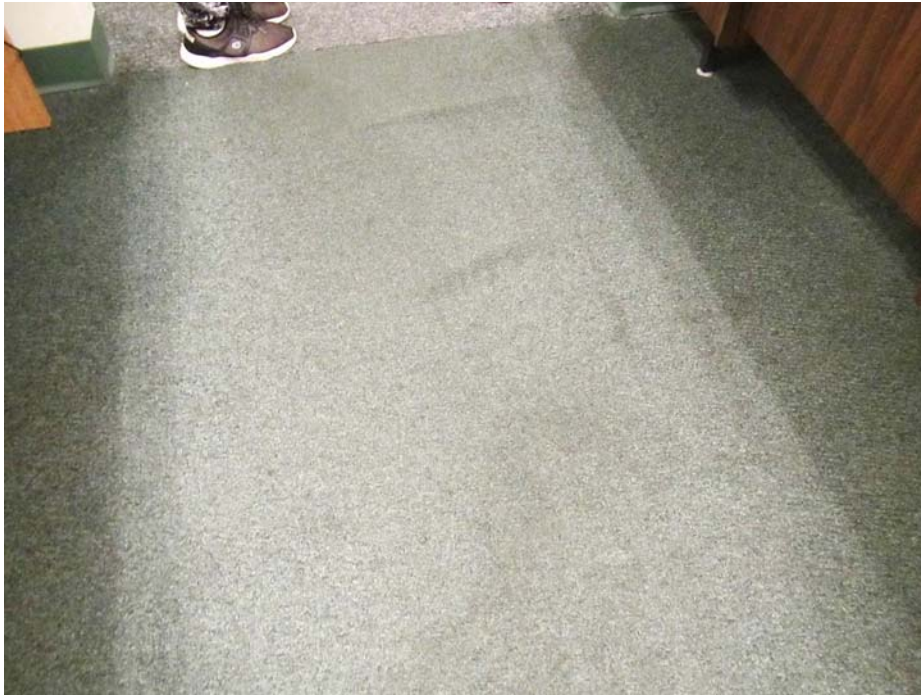
Picture 9

The offices were mostly carpeted. Some of the carpeting is new, in response to leaks as reported above, or as a part of the planned gradual change-out of all the carpeting in the building. Older carpeting, which was installed when the building was renovated into offices in 1999/2000, is stained, wrinkled, and worn in many areas (Picture 9). Aging carpet can produce fibers that can be irritating to the respiratory system. In addition, lumpy, torn or lifting carpet can create tripping hazards. Carpeting should be cleaned annually or semi-annually in soiled high traffic areas as per the recommendations of the Institute of Inspection, Cleaning, and Restoration Certification (IICRC, 2012).

Wrinkled and stained carpeting

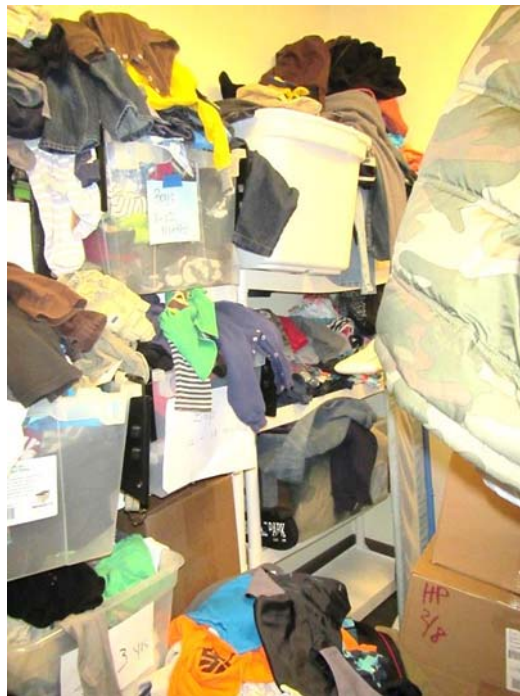
Picture 10

In some areas, stored materials and accumulated items make it more difficult for custodial staff to clean (Picture 10). It was reported that there is an ongoing process of finding better areas and ways to store items such as clothing, toys, and car seats in this office. Items should be stored neatly and moved periodically to allow for wet-wiping and vacuuming of surfaces. Items should also be stored off the floor to protect from dust and condensation.

Stored items, many not in bins

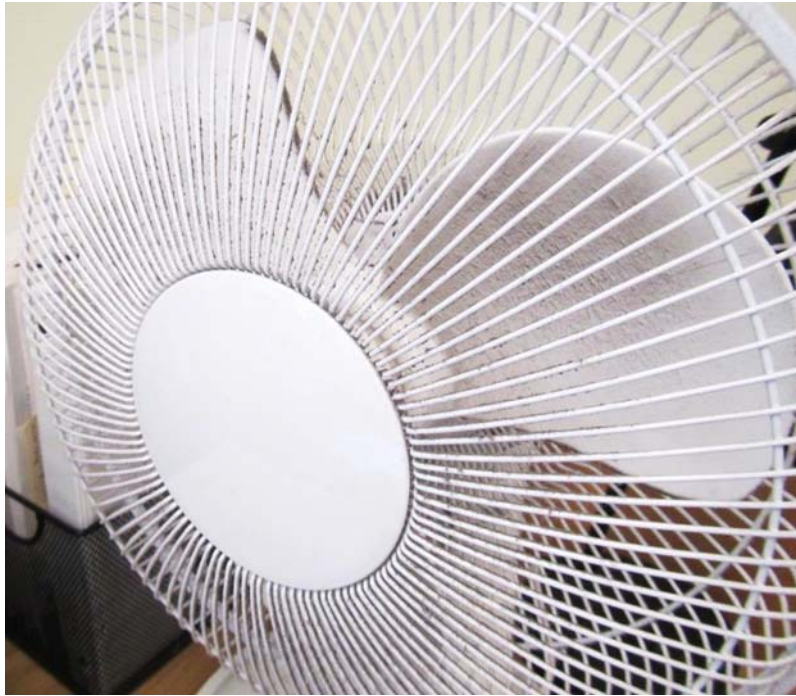
Picture 11

Personal fans were observed in a number of areas. Fan blades to some of these units had settled dust, which can be reaerosolized when the fan is activated (Picture 11). Some supply and exhaust vents were also dusty (Picture 12).

Dusty fan

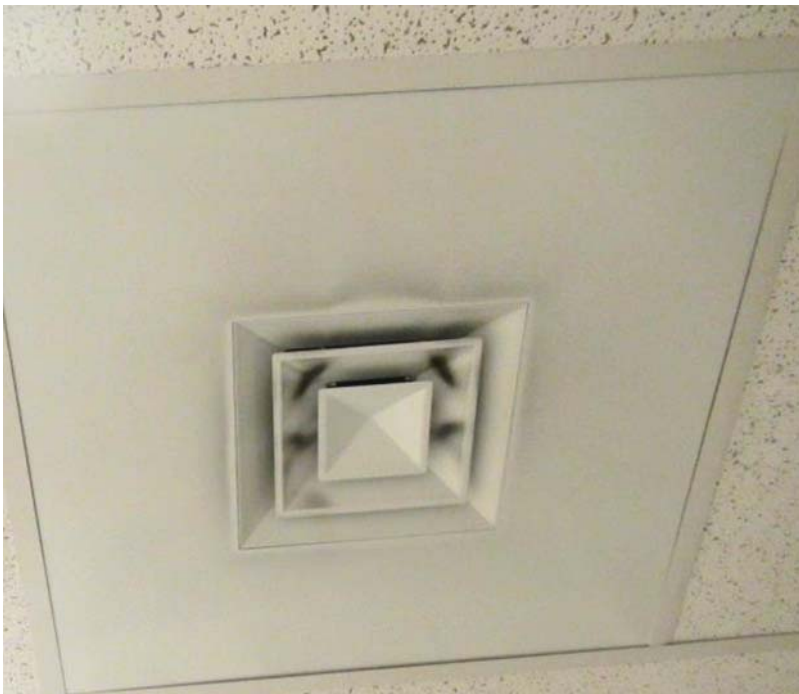
Picture 12

Dusty supply vent
